RE: Minor Municipal, SIC 4952, NPDES Compliance Evaluation Inspection, Mora Mutual Domestic Water and Sewer Association, NM0024966, April 27, 2016

NPDES Compliance Inspection Report

Mora Mutual Domestic Water and Sewer Association
NPDES Permit No. NM0024996
Compliance Evaluation Inspection
Inspection Date: April 27, 2016

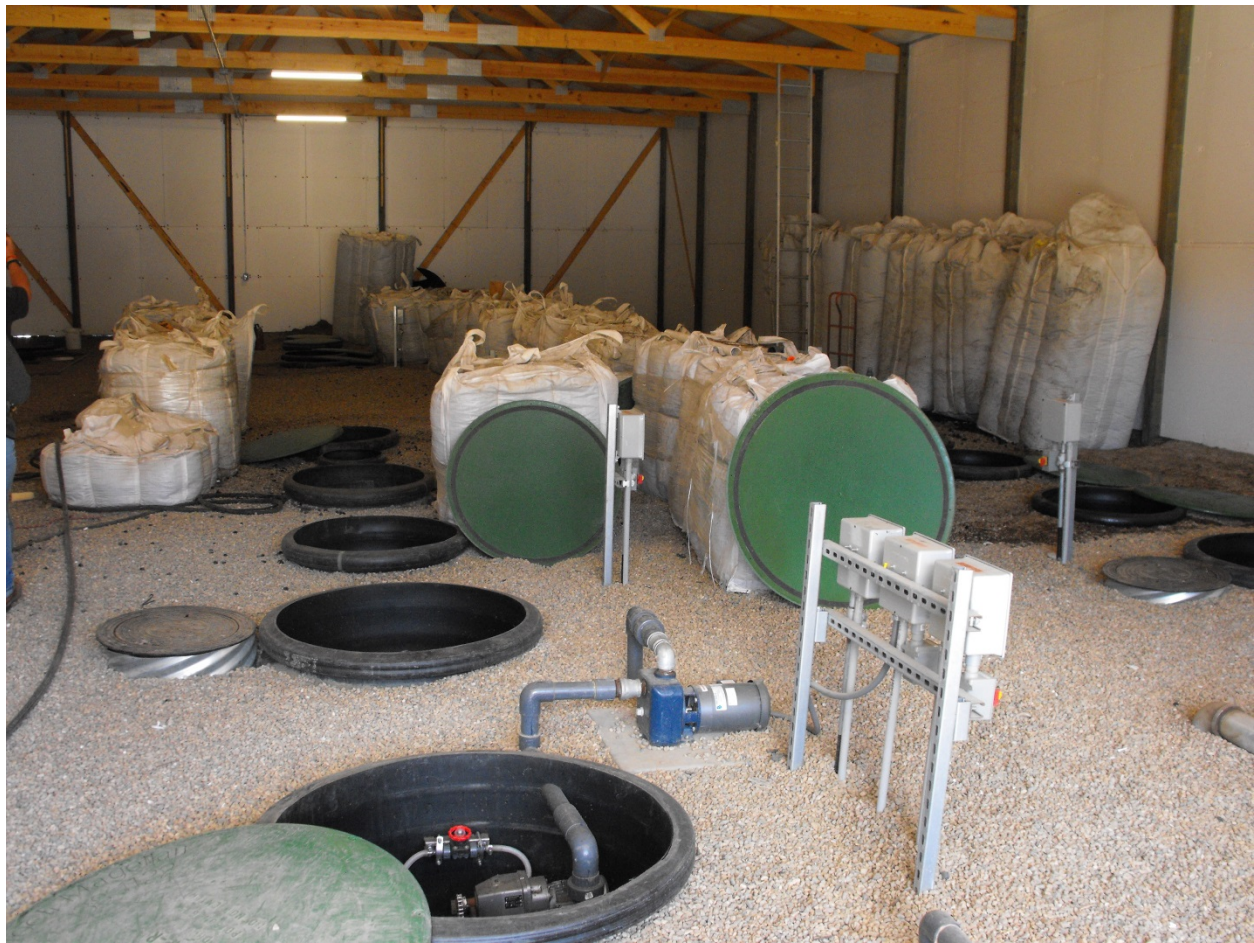
**NMED/SWQB
Official Photograph Log
Photo # 1**

Photographer: Daniel Valenta	Date: April 27, 2016	Time: 1117 Hours
City/County: Mora / Mora		State: New Mexico
Location: Mora Mutual Domestic Water and Sewer Association WWTP		
Subject: Overview of plant.

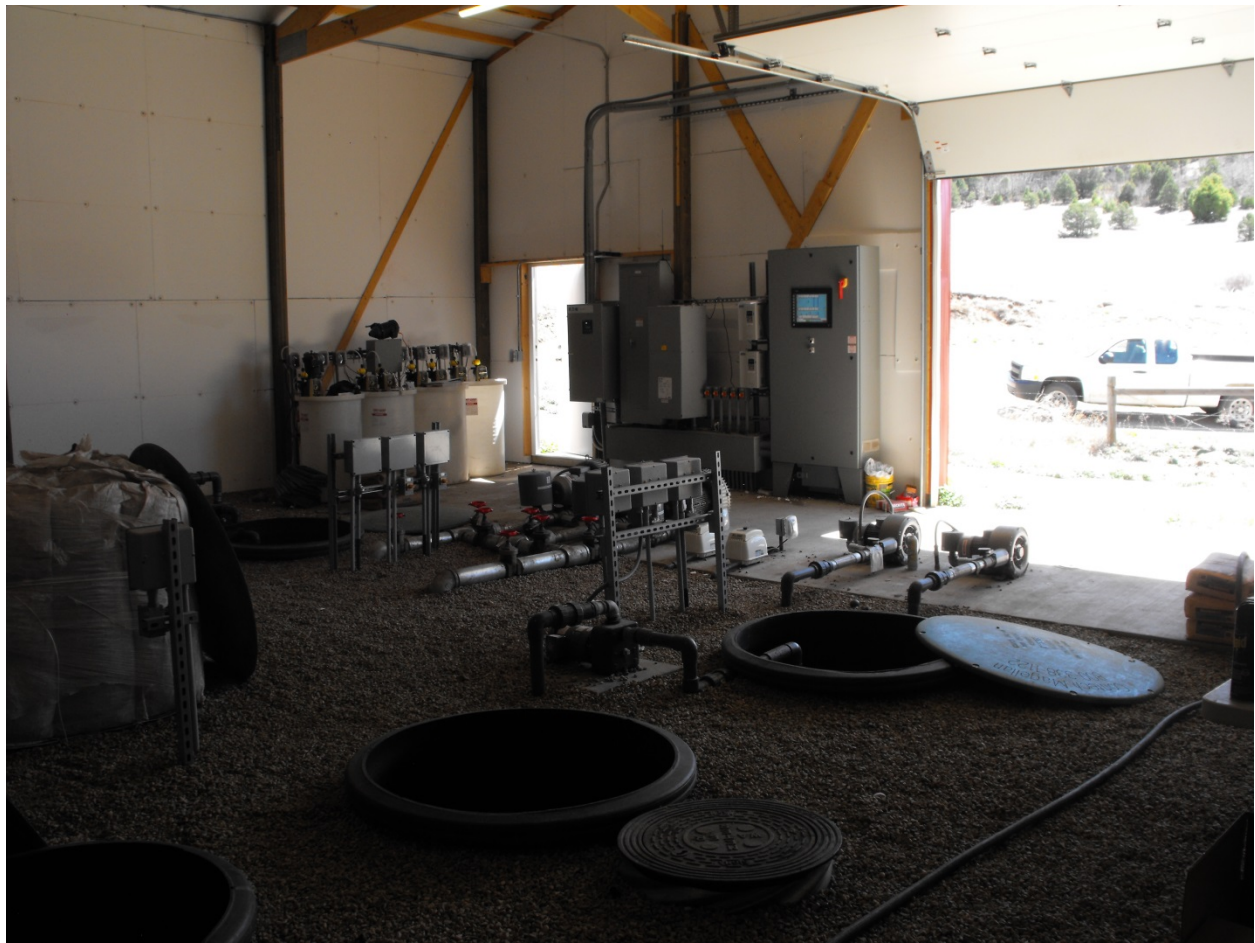
NMED/SWQB
Official Photograph Log
Photo # 2

Photographer: Daniel Valenta	Date: April 27, 2016	Time: 1128 Hours
City/County: Mora / Mora		State: New Mexico
Location: Mora Mutual Domestic Water and Sewer Association WWTP		
Subject: Overview of plant.

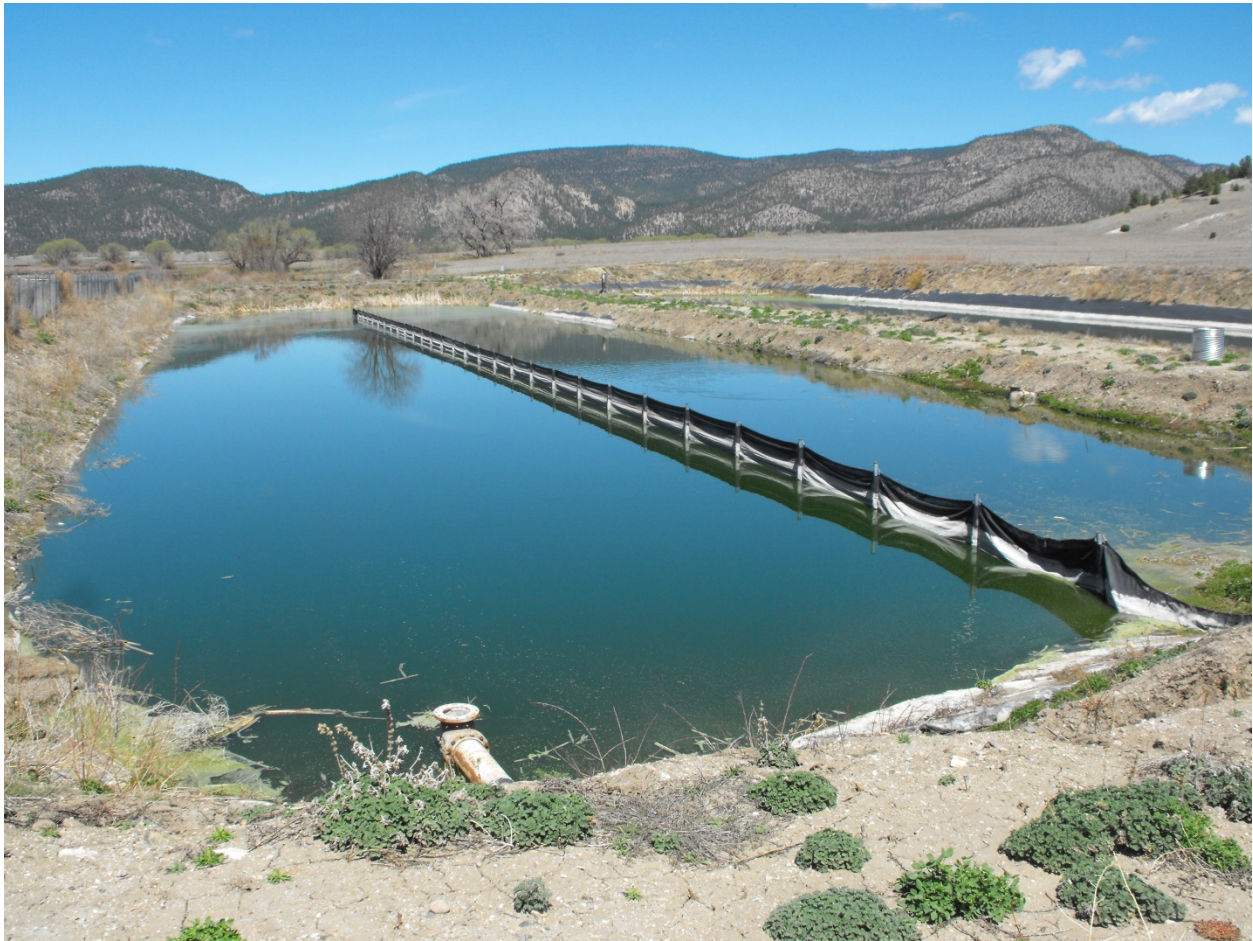
**NMED/SWQB
Official Photograph Log
Photo # 3**

Photographer: Daniel Valenta	Date: April 27, 2016	Time: 1142 Hours
City/County: Mora / Mora		State: New Mexico
Location: Mora Mutual Domestic Water and Sewer Association WWTP		
Subject: South Lagoon.

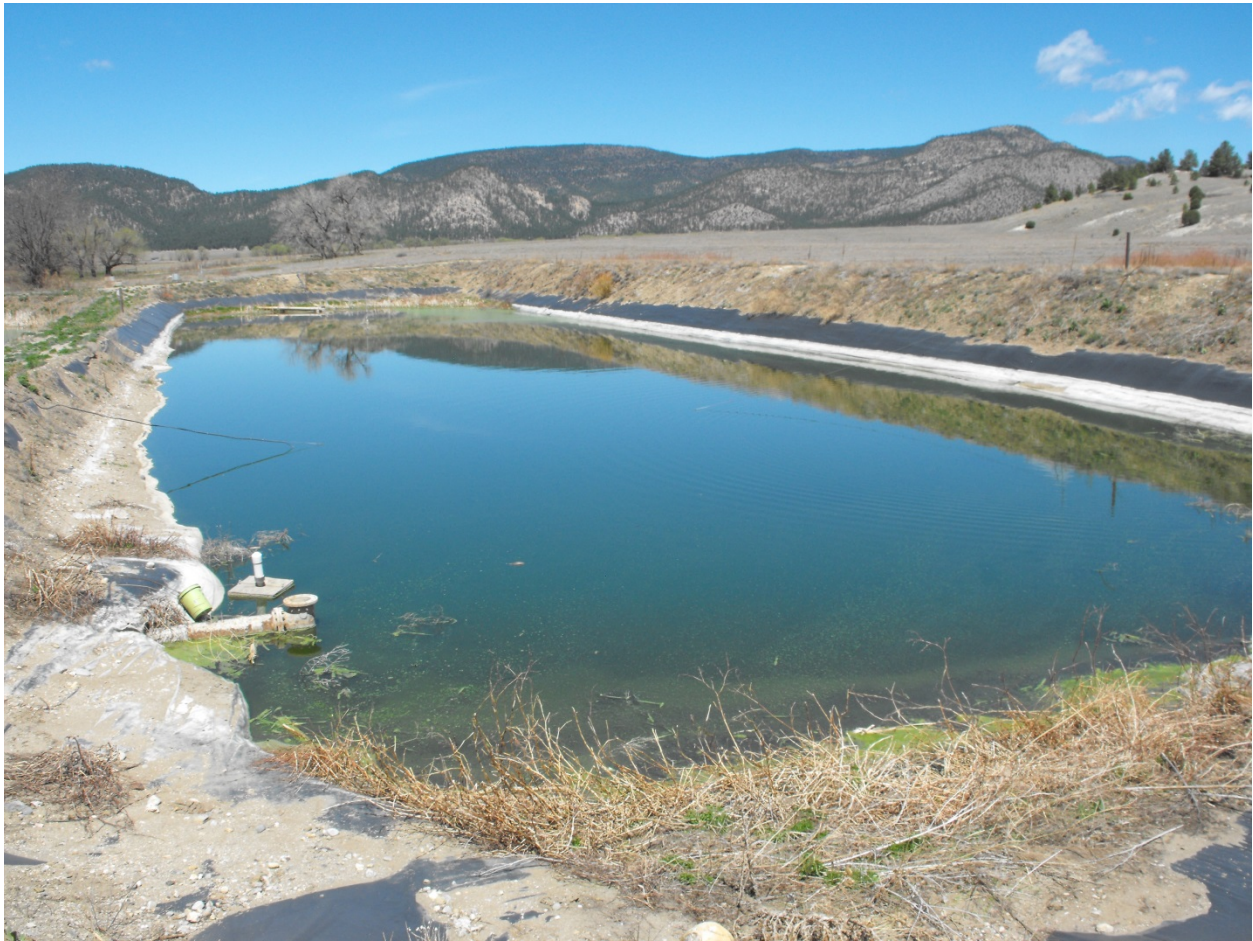
**NMED/SWQB
Official Photograph Log
Photo # 4**

Photographer: Daniel Valenta	Date: April 27, 2016	Time: 1143 Hours
City/County: Mora / Mora		State: New Mexico
Location: Mora Mutual Domestic Water and Sewer Association WWTP		
Subject: North Lagoon.

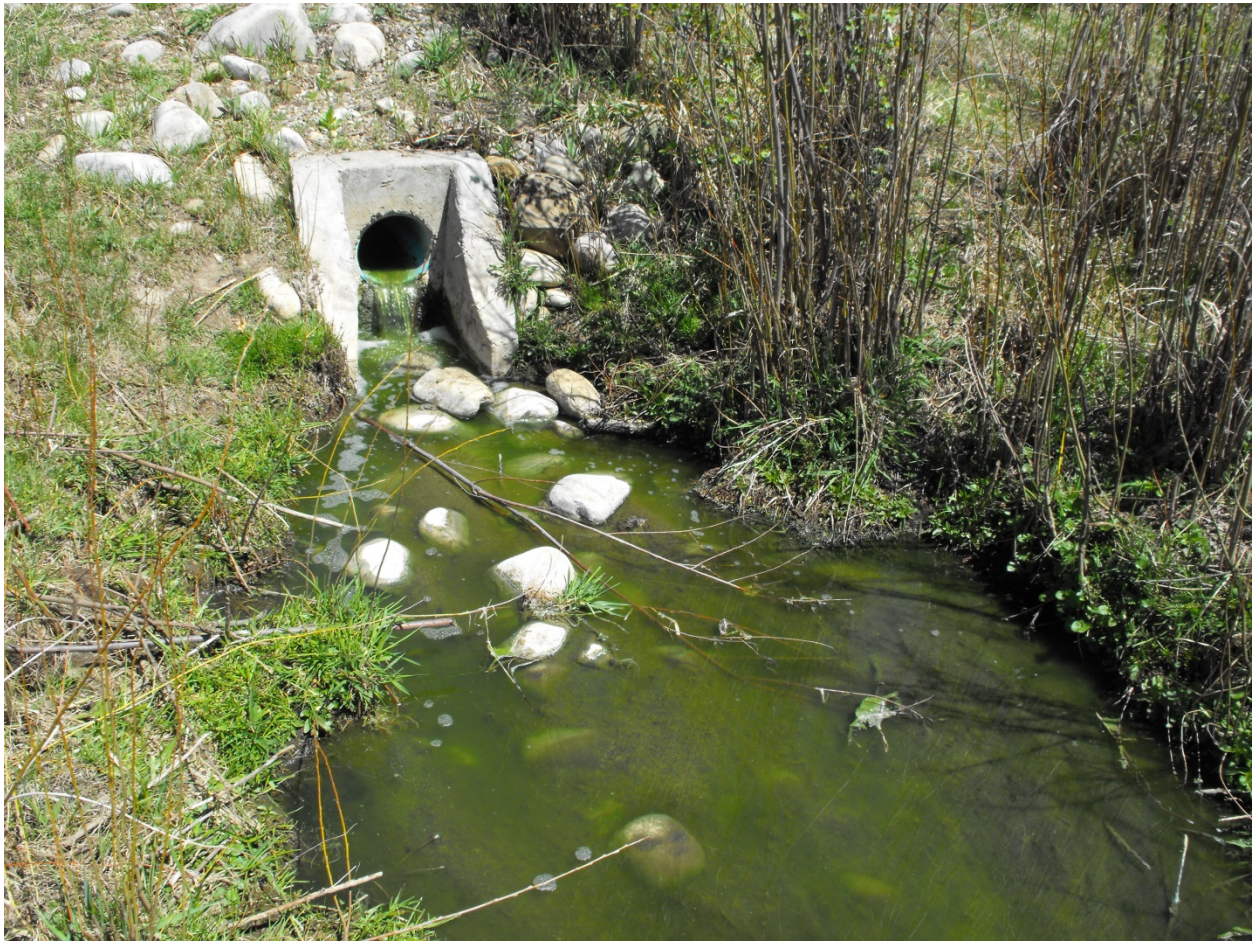
**NMED/SWQB
Official Photograph Log
Photo # 5**

Photographer: Daniel Valenta	Date: April 27, 2016	Time: 1210 Hours
City/County: Mora / Mora		State: New Mexico
Location: Mora Mutual Domestic Water and Sewer Association WWTP		
Subject: Discharge to the Mora River.
